**Flood Control Project Maintenance
Levee Inspections**
LMA District Cover Sheet
Spring 2020 Levee Inspection Results

Sutter Maintenance Yard East Levee Sacramento River

Spring 2020 Levee Inspection Results

| Waterway | | | Bank | Unit Miles |
|--|---|---|---|---|
| Unit No. 01 Sacramento River | | | Left | 19.85 |

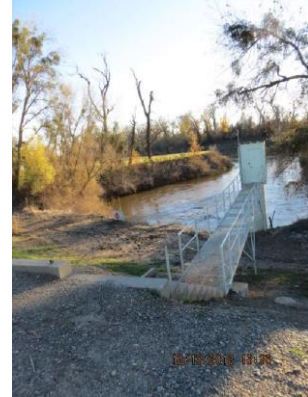
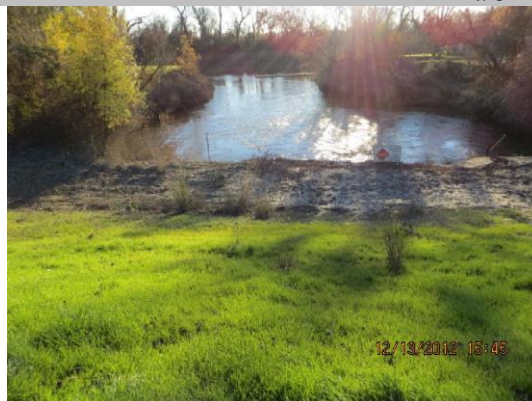
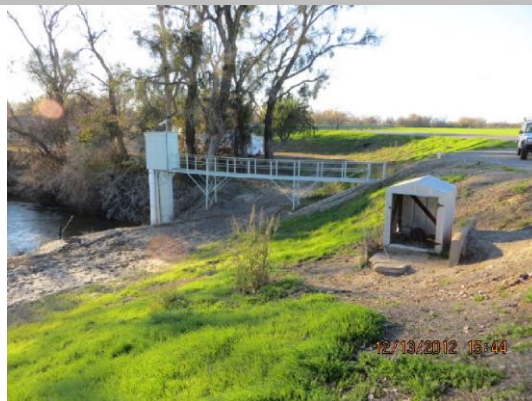
| DS_ID:17328 FS_ID:56002 EP_NO: 9497 Repair Type: Non-Urgent Crossing Status: Found UCIP Comments: 07/29/2019 Record has been updated from No Action Needed to Non-Urgent, no permit has been identified authorizing outfall structure. Structure drains water from Cherokee and Butte Slough into Sacramento River. Both inlet and outlet structures were underwater during inspection. Point of contact for Butte Slough Outfall Structure is Casey Wilder, DWR FMO-Sutter Yard Engineer. Obtained the 2008 underwater inspection of Butte Slough Flood Control Structure from Casey Wilder. Need to review report and obtain current maintenance records of structure. (O. Magana - DWR UCIP) 10/27/2017 This structure is inspected annually under the Structure and Channel Summer Inspection (part of the Levee Inspection Program) conducted by the DWR Flood Project Integrity and Inspection Branch (FPIIB). (DWR UCIP - O. Magana)04/24/2017 Both sides of crossing were underwater during site visit. Will revisit when water levels drop. (DWR Sutter Yard- AFreitag)11/07/2016 Crossing appears to be in good condition. (DWR Sutter Yard- AFreitag)06/06/2016 Crossing appears to be in good condition.04/06/2015 Good Condition. No issues.06/30/2014 Same as last inspection.12/30/2013 Same as last inspection.07/29/2013 Same as last inspection. FIELD_STRUCT_DESC: [Butte Slough Outfall Structure] 1 of 7: 66-inch drainage pipe of an unknown material through the levee, 30 feet below the crown. Slide gate on the Butte Slough side. Flap gate located on the Sacramento River side. (Automatic Board Order (ABO) issued as Permit No. 9497, 1974 - DWR). [Additional Reference(s): DWR Levee Log, 2002]. FS Date: 7/29/2019 10:58:00 AM | | | | | | |

WS view: overview towards gage station.

WS view: overview towards levee slope.

WS view: overview towards gage station and walkway.

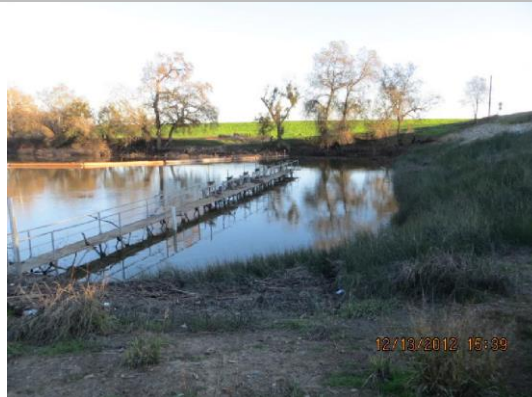
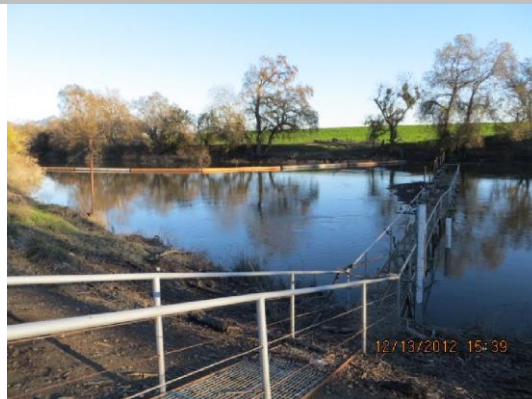
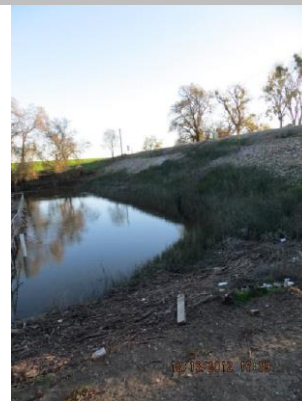
DS_ID:17524
FS_ID:56003
EP_NO: 9497
Repair Type: Non-Urgent
Crossing Status: Found
UCIP Comments: 07/29/2019 Record has been updated from No Action Needed to Non-Urgent, no permit has been identified authorizing outfall structure. Structure drains water from Cherokee and Butte Slough into Sacramento River. Both inlet and outlet structures were underwater during inspection. Point of contact for Butte Slough Outfall Structure is Casey Wilder, DWR FMO-Sutter Yard Engineer. Obtained the 2008 underwater inspection of Butte Slough Flood Control Structure from Casey Wilder. Need to review report and obtain current maintenance records of structure. (O. Magana - DWR UCIP) 10/27/2017 This structure is inspected annually under the Structure and Channel Summer Inspection (part of the Levee Inspection Program) conducted by the DWR Flood Project Integrity and Inspection Branch (FPIIB). (DWR UCIP - O. Magana)04/24/2017 Both sides of crossing were underwater during site visit. Will revisit when water levels drop. (DWR Sutter Yard- AFreitag)11/07/2016 Crossing appears to be in good condition. (DWR Sutter Yard- AFreitag)06/06/2016 Crossing appears to be in good condition.04/06/2015 Good Condition. No issues.06/30/2014 Same as last inspection.12/30/2013 Same as last inspection.07/29/2013 Same as last inspection.

FIELD_STRUCT_DESC: [Butte Slough Outfall Structure] 2 of 7: 66-inch drainage pipe of an unknown material through the levee, 30 feet below the crown. Slide gate on the Butte Slough side. Flap gate located on the Sacramento River side. (Automatic Board Order (ABO) issued as Permit No. 9497, 1974 - DWR). [Additional Reference(s): DWR Levee Log, 2002].
FS Date: 7/29/2019 10:59:00 AM

LS view: overview towards walkway.

LS view: steel walkway.

LS view: overview towards levee slope.

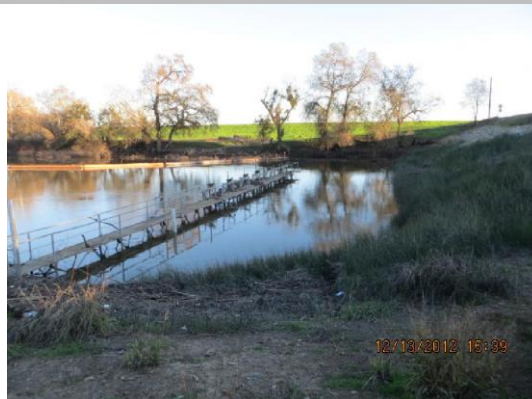
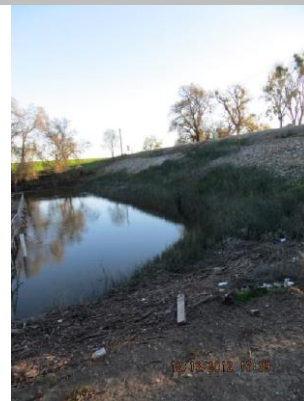
DS_ID:17525
FS_ID:56004
EP_NO: 9497
Repair Type: Non-Urgent
Crossing Status: Found
UCIP Comments: 07/29/2019 Record has been updated from No Action Needed to Non-Urgent, no permit has been identified authorizing outfall structure. Structure drains water from Cherokee and Butte Slough into Sacramento River. Both inlet and outlet structures were underwater during inspection. Point of contact for Butte Slough Outfall Structure is Casey Wilder, DWR FMO-Sutter Yard Engineer. Obtained the 2008 underwater inspection of Butte Slough Flood Control Structure from Casey Wilder. Need to review report and obtain current maintenance records of structure. (O. Magana - DWR UCIP) 10/27/2017 This structure is inspected annually under the Structure and Channel Summer Inspection (part of the Levee Inspection Program) conducted by the DWR Flood Project Integrity and Inspection Branch (FPIIB). (DWR UCIP - O. Magana)04/24/2017 Both sides of crossing were underwater during site visit. Will revisit when water levels drop. (DWR Sutter Yard- AFreitag)11/07/2016 Crossing appears to be in good condition. (DWR Sutter Yard- AFreitag)06/06/2016 Crossing appears to be in good condition.04/06/2015 Good Condition. No issues.06/30/2014 Same as last inspection.12/30/2013 Same as last inspection.07/29/2013 Same as last inspection.

FIELD_STRUCT_DESC: [Butte Slough Outfall Structure] 3 of 7: 66-inch drainage pipe of an unknown material through the levee, 30 feet below the crown. Slide gate on the Butte Slough side. Flap gate located on the Sacramento River side. (Automatic Board Order (ABO) issued as Permit No. 9497, 1974 - DWR). [Additional Reference(s): DWR Levee Log, 2002].
FS Date: 7/29/2019 11:00:00 AM

LS view: overview towards walkway.

LS view: overview towards levee slope.

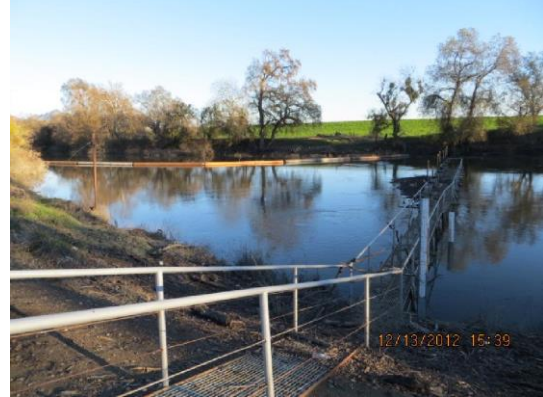
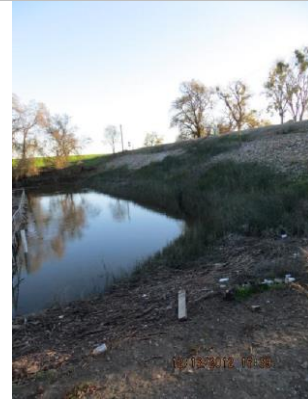
DS_ID:17527
FS_ID:56006
EP_NO: 9497
Repair Type: Non-Urgent
Crossing Status: Found
UCIP Comments: 07/29/2019 Record has been updated from No Action Needed to Non-Urgent, no permit has been identified authorizing outfall structure. Structure drains water from Cherokee and Butte Slough into Sacramento River. Both inlet and outlet structures were underwater during inspection. Point of contact for Butte Slough Outfall Structure is Casey Wilder, DWR FMO-Sutter Yard Engineer. Obtained the 2008 underwater inspection of Butte Slough Flood Control Structure from Casey Wilder. Need to review report and obtain current maintenance records of structure. (O. Magana - DWR UCIP) 10/27/2017 This structure is inspected annually under the Structure and Channel Summer Inspection (part of the Levee Inspection Program) conducted by the DWR Flood Project Integrity and Inspection Branch (FPIIB). (DWR UCIP - O. Magana)04/24/2017 Both sides of crossing were underwater during site visit. Will revisit when water levels drop. (DWR Sutter Yard- AFreitag)11/07/2016 Crossing appears to be in good condition. (DWR Sutter Yard- AFreitag)06/06/2016 Crossing appears to be in good condition.04/06/2015 Good Condition. No issues.06/30/2014 Same as last inspection.12/30/2013 Same as last inspection.07/29/2013 Same as last inspection.

LS view: steel walkway.

LS view: overview towards levee slope.

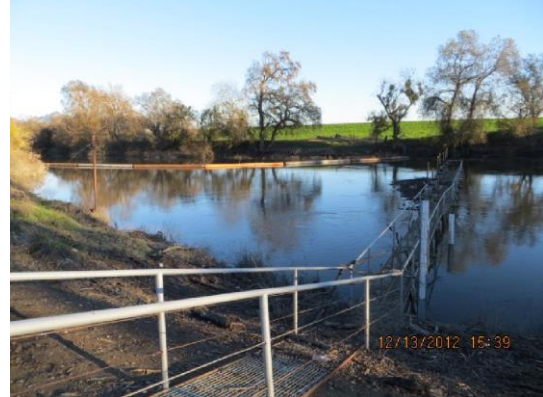
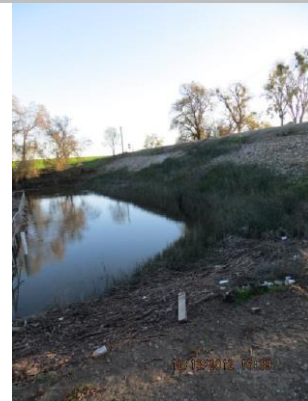
DS_ID:17528
FS_ID:56007
EP_NO: 9497
Repair Type: Non-Urgent
Crossing Status: Found
UCIP Comments: 07/29/2019 Record has been updated from No Action Needed to Non-Urgent, no permit has been identified authorizing outfall structure. Structure drains water from Cherokee and Butte Slough into Sacramento River. Both inlet and outlet structures were underwater during inspection. Point of contact for Butte Slough Outfall Structure is Casey Wilder, DWR FMO-Sutter Yard Engineer. Obtained the 2008 underwater inspection of Butte Slough Flood Control Structure from Casey Wilder. Need to review report and obtain current maintenance records of structure. (O. Magana - DWR UCIP) 10/27/2017 This structure is inspected annually under the Structure and Channel Summer Inspection (part of the Levee Inspection Program) conducted by the DWR Flood Project Integrity and Inspection Branch (FPIIB). (DWR UCIP - O. Magana)04/24/2017 Both sides of crossing were underwater during site visit. Will revisit when water levels drop. (DWR Sutter Yard- AFreitag)11/07/2016 Crossing appears to be in good condition. (DWR Sutter Yard- AFreitag)06/06/2016 Crossing appears to be in good condition.04/06/2015 Good Condition. No issues.06/30/2014 Same as last inspection.12/30/2013 Same as last inspection.07/29/2013 Same as last inspection.

LS view: steel walkway.

LS view: overview towards levee slope.

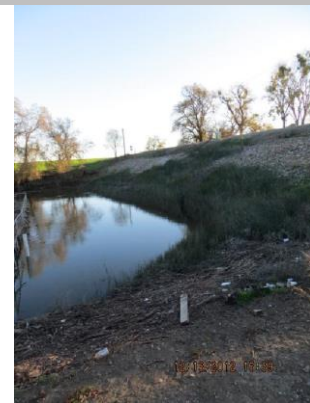
DS_ID:17529
FS_ID:56008
EP_NO: 9497
Repair Type: Non-Urgent
Crossing Status: Found
UCIP Comments: 07/29/2019 Record has been updated from No Action Needed to Non-Urgent, no permit has been identified authorizing outfall structure. Structure drains water from Cherokee and Butte Slough into Sacramento River. Both inlet and outlet structures were underwater during inspection. Point of contact for Butte Slough Outfall Structure is Casey Wilder, DWR FMO-Sutter Yard Engineer. Obtained the 2008 underwater inspection of Butte Slough Flood Control Structure from Casey Wilder. Need to review report and obtain current maintenance records of structure. (O. Magana - DWR UCIP) 10/27/2017 This structure is inspected annually under the Structure and Channel Summer Inspection (part of the Levee Inspection Program) conducted by the DWR Flood Project Integrity and Inspection Branch (FPIIB). (DWR UCIP - O. Magana)04/24/2017 Both sides of crossing were underwater during site visit. Will revisit when water levels drop. (DWR Sutter Yard- AFreitag)11/07/2016 Crossing appears to be in good condition. (DWR Sutter Yard- AFreitag)06/06/2016 Crossing appears to be in good condition.04/06/2015 Good Condition. No issues.06/30/2014 Same as last inspection.12/30/2013 Same as last inspection.07/29/2013 Same as last inspection.

LS view: overview towards levee slope.

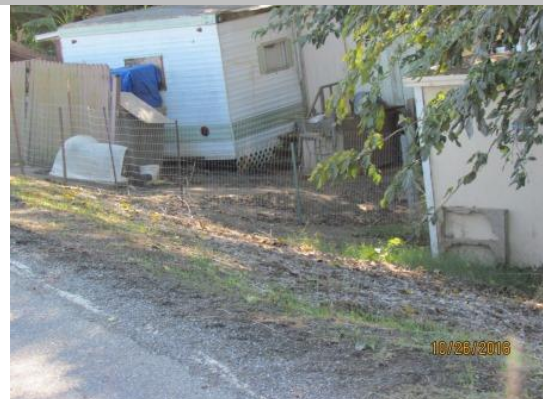
View of the trailers and building on the waterside.

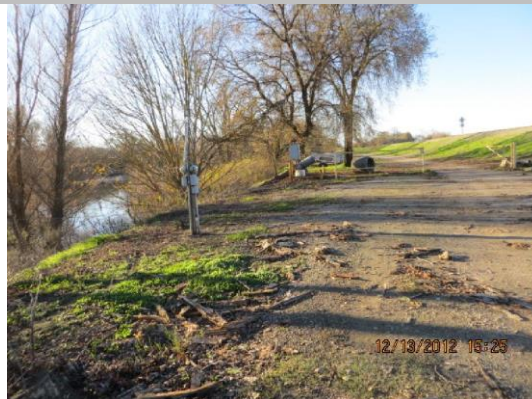
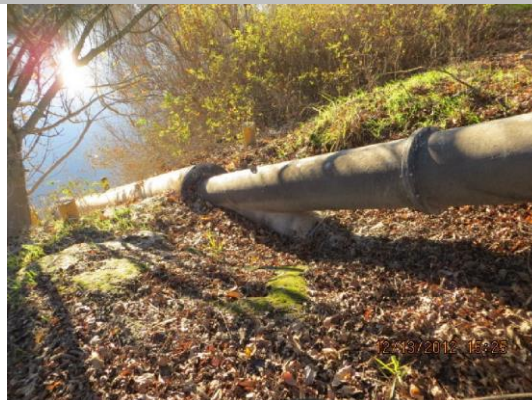
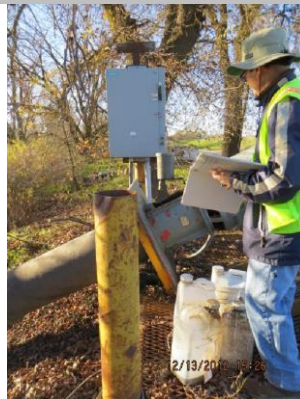
| DS_ID:17317 FS_ID:56009 EP_NO: 12714 Repair Type: Urgent Crossing Status: Found UCIP Comments: 07/29/2019 Record has been updated from No Action Needed to Urgent, soil has been disturbance on the LS toe with signs of ponding water. Unable to determine extent of disturbance near levee toe due to vegetation. Need to contact owner of potential pipe leak or determine source of ponding water near LS toe. (O. Magana - DWR UCIP)04/24/2017 Crossing appears to be in good condition. (DWR Sutter Yard- A Freitag)11/07/2016 Crossing appears to be in good condition. (DWR Sutter Yard- A Freitag)06/06/2016 Crossing appears to be in good condition.04/06/2015 Good Condition. No issues. Ground valve on LS.06/30/2014 Same as last inspection.12/30/2013 Same as last inspection.07/29/2013 Same as last inspection. FIELD_STRUCT_DESC: 16-inch asphalt coated steel irrigation pipe and 2-inch electrical conduit through the levee, 3 feet below the crown. Pump on the waterside (WS) berm. Standpipe and service pole at the landside (LS) toe. (Permit No. 12714, 1979 - Wilber). [Additional Reference(s): DWR Levee Log, 2002]. FS Date: 7/29/2019 11:04:00 AM | | | | | | |

WS view: overview

WS view: overview of inclined pipe

WS view: overview of pump and switch board

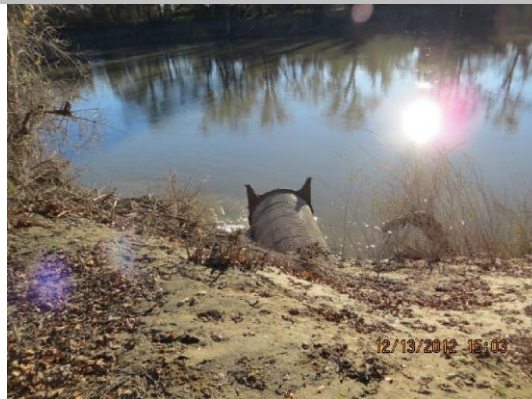
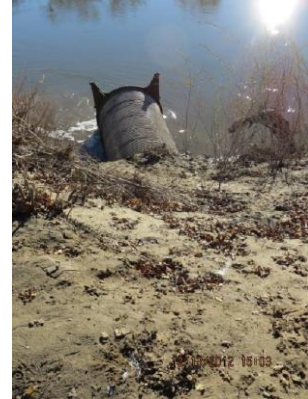
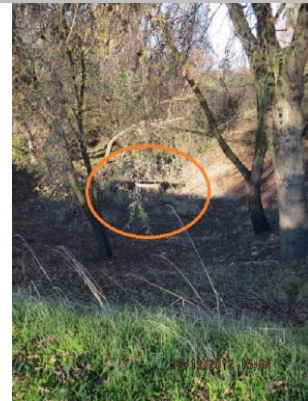
WS view: overview towards CMP sewer pipe

WS view: water flowing from CMP sewer pipe

LS view: overview

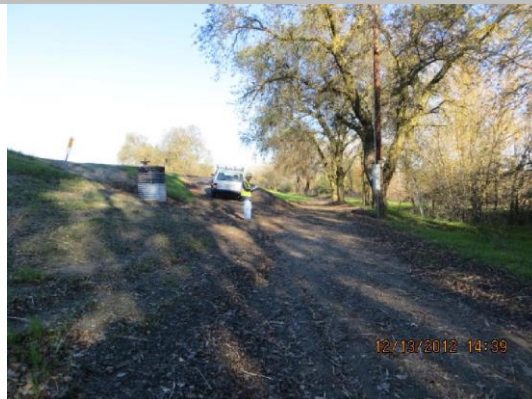
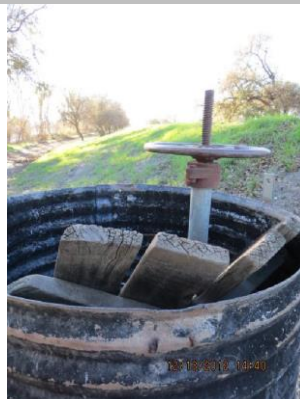
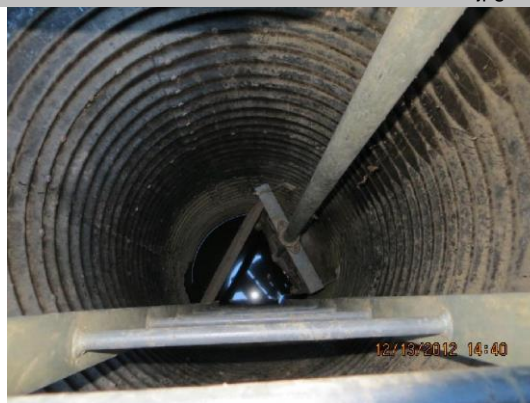
DS_ID:17319
FS_ID:56012
EP_NO: 9527
Repair Type: Urgent
Crossing Status: Found
UCIP Comments: 07/29/2019 Record remains Urgent; same as 2018 inspection. Steep LS slope is causing slope to slip. LS outlet is buried. Need to audit record to determine current owner, pipe is associated to ABO. (O. Magana - DWR UCIP)08/30/2018 WS vegetation completely overgrown towards walkway and pump so could not inspect. WS pipe end is nearly completely covered in debris, pipe cap appears either open or broken, LS erosion still present, and pipe end completely covered in debris so crossing remains Urgent (D. Sanoski - DWR UCIP).04/24/2017 LS slope damage is still present. No repairs have been made to this crossing yet. (DWR Sutter Yard- AFreitag)11/07/2016 No LS repairs have been made yet. (DWR Sutter Yard- AFreitag)06/06/2016 New flow meter installed on WS. Walkway to access the pump is overgrown with vegetation and not accessible. (DWR Sutter Yard - afreitag) 04/05/2016 Caved-in slope on landside (LS) not yet repaired. Leaky pipe marker gone. Per Bob Duffey (DWR FPIIB inspector), pipe will be replaced by owner next year. If not, will go to CVFPB enforcement. (DWR UCIP - kfazel)04/06/2015 Pipe leaks during times of High water. Slope damage still present. Needs a more detailed inspection to find the leak. (DWR Sutter Yard - afreitag)06/30/2014 Same as last inspection. (DWR Sutter Yard - afreitag)12/30/2013 Same as last inspection. (DWR Sutter Yard - afreitag)07/29/2013 Pipe does not appear to be abandoned. On the WS it appears that a smaller pipe was sleeved into the 18in. Pipe and then the difference capped and welded. Pump was not running at time of inspection but LS ditch near outlet was wet. LS slope damage and leaky pipe marker are still present. (DWR Sutter Yard - afreitag)12/13/2012 Abandoned and plugged/capped steel pipe on WS berm. DWR leaky pipe marker on LS (12-3). Slope failure on LS. Needs capping of LS steel pipe after detailed investigation. (DWR UCIP - pamatya)

FIELD_STRUCT_DESC: 18-inch steel irrigation pipe through the levee, 12.5 feet below the crown. Gate valve on the waterside (WS). Vertical pump on the WS bank. Flow meter on the WS. (Automatic Board Order (ABO) issued as Permit No. 9527, 1974 - Butte Creek Farms)
[Additional Reference(s): DWR Levee Log, 2002. USACE Sacramento O&M Manual 136, March 1960 (HLM 1.1)].
FS Date: 7/29/2019 11:07:00 AM

WS view: overview

WS view: CMP riser with slide gate

WS view: inside CMP riser

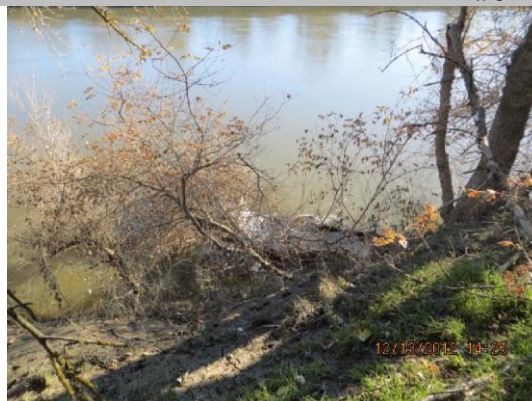
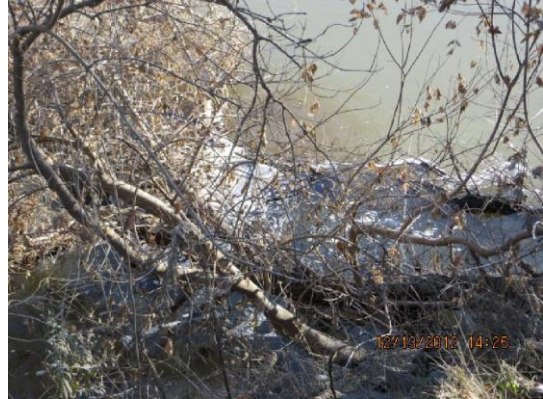
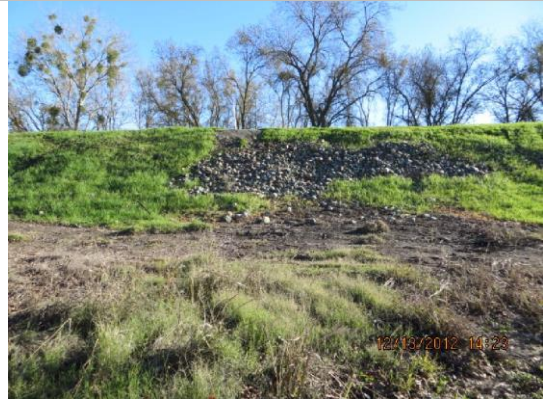
DS_ID:17320
FS_ID:56013
EP_NO: 9543
Repair Type: Urgent
Crossing Status: Found
UCIP Comments: 07/29/2019 same as 2018 inspection, Urgent. No access is available to WS due to dense vegetation, assume WS pipe is still completely deteriorated. Recommend internal inspection to determine the damage, if any, through the levee. (O. Magana - DWR UCIP)08/30/2018 WS vegetation too thick to clearly inspect WS pipe so assume same condition as last inspections so crossing remains Urgent due to pipe integrity. WS levee slope looks good. No signs of levee threat to the road crown. LS headwall looks in good condition (D. Sanoski - DWR UCIP).04/24/2017 WS was underwater during the site visit but I do not believe that any repairs have been made to this crossing yet. (DWR Sutter Yard- AFreitag)11/07/2016 No repairs have been made here yet. (DWR Sutter Yard- AFreitag)06/17/2016 River levels were down and the WS pipe end was exposed. WS end is completely rotten and damaged and flap gate has fallen off the end of the pipe (see pics). Pipe needs to be replaced or repaired. (DWR Sutter Yard - afreitag)04/05/2016 Erosion on WS slope still present. Pipe still fully submerged on WS and discharging into river during site visit. (DWR UCIP - kfazel)04/06/2015 Pipe leaks during high water. DWR employee said he suspects that the flap gate has rotted and fallen off WS end of pipe. Could not locate WS end of pipe to confirm. Water was flowing through this drain during field survey. (DWR Sutter Yard - afreitag)06/30/2014 Same as last inspection. (DWR Sutter Yard - afreitag)12/30/2013 Same as last inspection. (DWR Sutter Yard - afreitag)07/29/2013 Same as last inspection. (DWR Sutter Yard - afreitag) 12/13/2012 Water was flowing through this drain during field survey. (DWR UCIP - pamatya)

FIELD_STRUCT_DESC: 30-inch corrugated metal drainage pipe (at 45 degrees) through the levee, 25.2 feet below the crown. Flap gate on the waterside (WS), not found in 2016. (30-inch pipe [HLM 1.38] authorized under Automatic Board Order (ABO) issued as Permit No. 9543, 1974 - Harada). [Additional Reference(s): DWR Levee Log, 2002. USACE Sacramento O&M Manual 136, revision March 1960 (HLM 1.38)]
FS Date: 7/29/2019 11:08:00 AM

WS view: overview of river bank

WS view: water flowing from outlet pipe (pipe fully submerge)

LS view: overview of levee slope

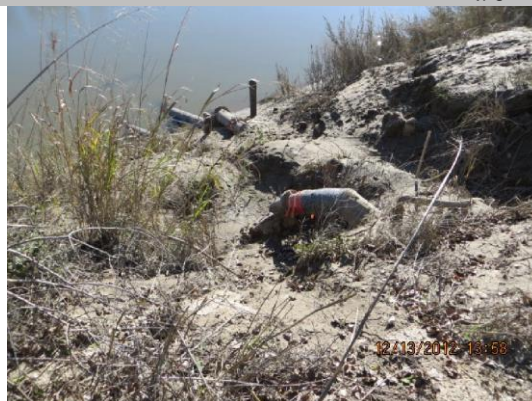
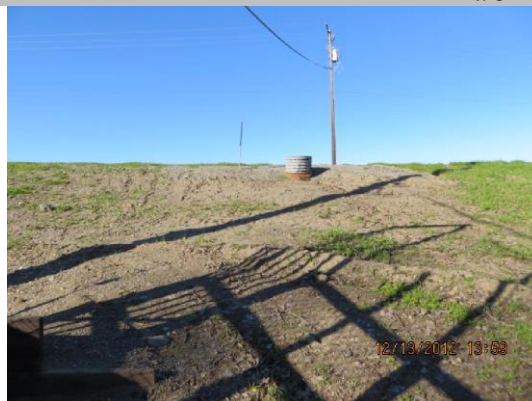
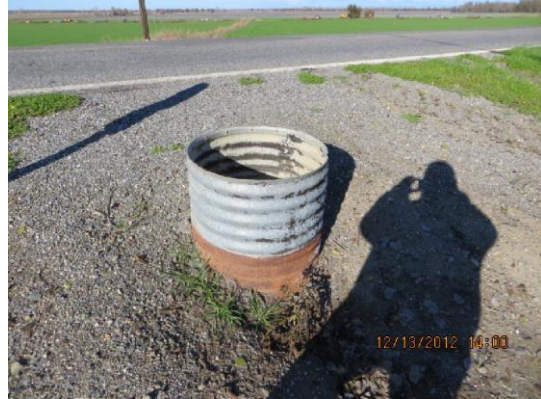
DS_ID:17322
FS_ID:56014
EP_NO: 9258
Repair Type: Non-Urgent
Crossing Status: Found
UCIP Comments: 07/29/2019 Record remains Non-Urgent, limited inspection due safety concern. Limited inspection due to steep WS slope. Encroachment has been abandoned. Abandoned section of pipe through WS bank slope was found. Two structures were found on WS bank unable to tell whether old walkway structure or 10-inch pipe are still being use. (O. Magana - DWR UCIP)04/24/2017 WS riser was still full of soil. Open 10" pipe on the WS bank was underwater during time of site visit. (DWR Sutter Yard- A/Freitag)11/07/2016 WS riser still full of soil. No pump present and 10" pipe left opened on the WS. (DWR Sutter Yard- A/Freitag)06/17/2016 Same as last inspection.

WS view: overview

WS view: overview of CMP riser

WS view: CMP riser

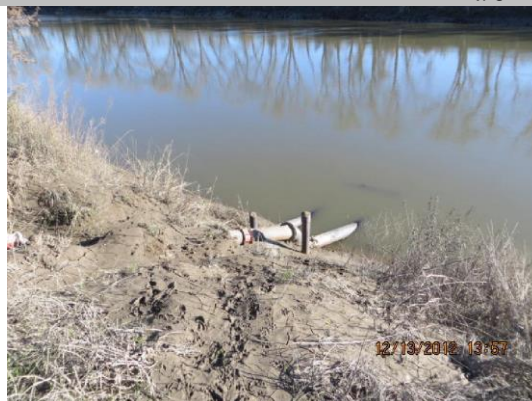
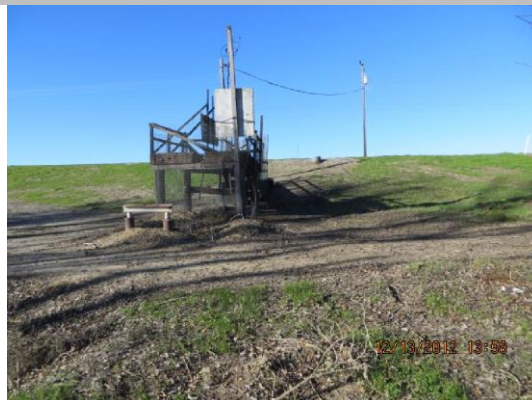
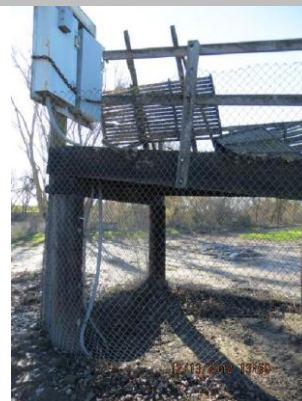
DS_ID:17321
FS_ID:56015
EP_NO: 9543
Repair Type: Non-Urgent
Crossing Status: Found
UCIP Comments: 07/29/2019 Record remains Non-Urgent, modifications were made as of 2012 to the existing structure (new walkway structure located on WS berm edge). Unable to determine whether an official permit was issued for the structure improvements on the WS. No ABO updates were found through permit_edit. Need to determine owner for this structure and obtain details of all improvements made for this structure. (O. Magana - DWR UCIP)08/30/2018 BRAND-NEW pipe and pump structure installed at this location. Pump in operation at time of inspection and no leaks were visible. Downgraded to Non-Urgent; will be further downgraded to No Action Needed when paperwork compliance with CVFPB is confirmed (D. Sanoski - DWR UCIP).04/24/2017 Abandoned and needs to be done so properly. Vegetation was too thick on the LS slope to see and sloughing or slope damage. (DWR Sutter Yard- AFreitag)11/07/2016 Abandoned. (DWR Sutter Yard- AFreitag)06/17/2016 Abandoned crossing. (DWR Sutter Yard - afreitag)04/05/2016 Appears abandoned and should be done so properly. LS levee slope has a slight but sudden drop (could be due to improper compaction). Dense vegetation on LS prevented visibility of sloughing or other damage to levee. Could not locate leaky pipe marker. Per Bryan Reniff of Sutter Yard, marker was previously installed due to a high water event, not leaky pipe. Appears repair work to levee performed but unclear of extent. Gate valve on WS is bent and damaged, appears abandoned. Crossing a good candidate for video inspection. (DWR UCIP - kfazel)04/06/2015 Sloughing LS slope and river bank. DWR marking for leaky pipe. (DWR Sutter Yard - afreitag)06/30/2014 Same as last inspection. (DWR Sutter Yard - afreitag)12/30/2013 Same as last inspection. (DWR Sutter Yard - afreitag)07/29/2013 Same as last inspection. (DWR Sutter Yard - afreitag)12/13/2012 Sloughing LS slope and river bank. DWR marking for leaky pipe. (DWR UCIP - pamatya)

FIELD_STRUCT_DESC: BRAND-NEW: 14-inch concrete encased steel irrigation pipe through the levee, 12.5 feet below the crown. Slant pump mounted on a pile structure on the waterside (WS) berm. Slide gate in a 48-inch riser on the WS berm with a walkway to the pump. Pipe discharges into a concrete distribution box at the landside (LS) toe. Flap gate on the LS end. Electrical conduit mounted to power poles on the LS and WS for service to the pump on the WS. Electrical conduits may partially penetrate both embankments. (Automatic Board Order (ABO) issued as Permit No. 9543, 1974 - Harada). [Additional Reference(s): DWR Levee Log, 2002. USACE Sacramento O&M Manual 136, March 1960 (HLM 1.84)].

WS view: pipe @river bank

WS view: abandoned pump station.

WS view: abandoned pump station close-up.

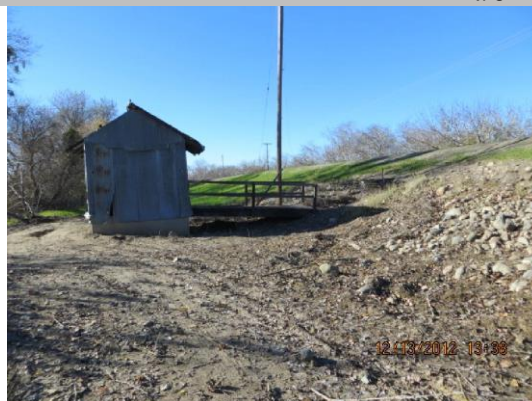
DS_ID:17305
FS_ID:56016
EP_NO: 9541
Repair Type: Non-Urgent
Crossing Status: Found
UCIP Comments: 07/29/2019 Record remains Non-Urgent, pipe has been modified and no permit has been identified authorizing pipe. Pipe was previously noted as abandoned however, PG&E smart meter was active during site inspection. Pipe appears to be in use and operable. Need to find current owner to update record. (O. Magana - DWR UCIP)04/24/2017 Abandoned and needs to be done so properly. (DWR Sutter Yard- A Freitag)11/07/2016 Abandoned. (DWR Sutter Yard- A Freitag)06/06/2016 Abandoned crossing. Should be properly abandoned.04/06/2015 Same as last inspection. CMP standpipe with gate valve. Abandoned pump house. Pipe discharges into open ditch at landward toe- not found.06/30/2014 Same as last inspection.12/30/2013 Same as last inspection.07/29/2013 Same as last inspection.
FIELD_STRUCT_DESC: 24-inch steel irrigation pipe through the levee, 13.5 feet below the crown. Pump in a metal house on the WS (waterside) berm. Slide gate in a corrugated metal pipe riser on the WS slope. Service pole and guy wire anchor on the WS slope. (Automatic Board Order (ABO) issued as Permit No. 9541, 1974 - Wilbur, McGowan, Zinke). [Additional Reference(s): DWR Levee Logs, 2002. USACE Sacramento O&M Manual 136, March 1960 (HLM 2.01)].

WS view: overview

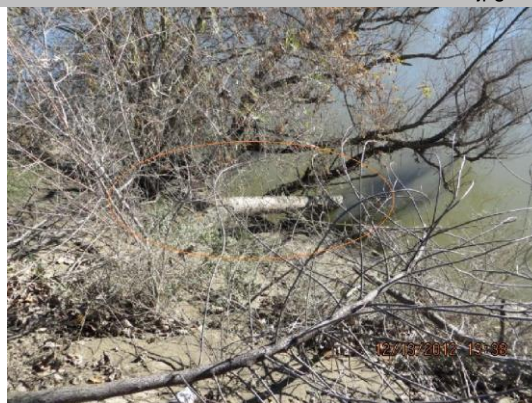
Photo 2 of 3 : UCIP_SP_2020_56016_47011.jpg

WS view: overview of pipe

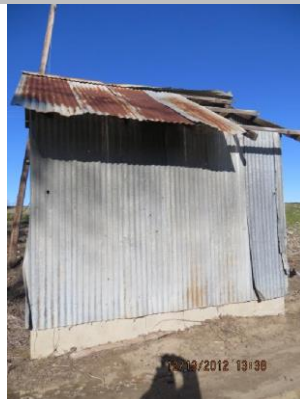
Photo 3 of 3 : UCIP_SP_2020_56016_47012.jpg

WS view: abandoned pump house

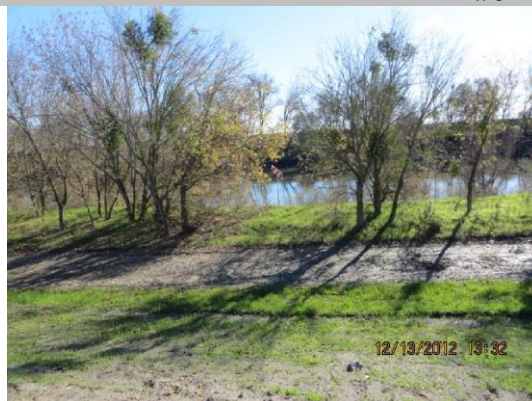
Photo 1 of 3 : UCIP_SP_2020_56017_47020.jpg

DS_ID:17308
FS_ID:56017
EP_NO: 7343
Repair Type: Non-Urgent
Crossing Status: Indicator Found
UCIP Comments: 07/29/2019 Record has been updated from No Action Needed to Non-Urgent, no maintenance records were available to determine status of line. Need to contact owner to determine the condition of the line. No maintenance or inspection records were available to determine condition of the line through the levee. Sign previously attached to posts is now laying on the WS slope. (O. Magana - DWR UCIP)04/24/2017 Crossing appears to be in good condition. (DWR Sutter Yard- AFreitag)11/07/2016 Crossing appears to be in good condition. (DWR Sutter Yard- AFreitag)06/06/2016 Crossing appears to be in good condition.04/06/2015 Same as last inspection.06/30/2014 Same as last inspection.12/30/2013 Same as last inspection.07/29/2013 Same as last inspection.
FIELD_STRUCT_DESC: 8-inch asphalt coated steel gas pipeline through the levee, 3.5 feet below the crown. Gas line markers found on both sides of the levee. (Permit No. 7343, 1971 - Pacific Gas and Electric Company). [Additional Reference(s): DWR Levee Log, 2002].

WS view: overview

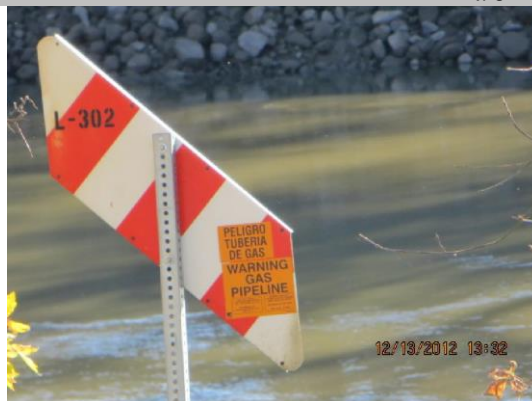
Photo 2 of 3 : UCIP_SP_2020_56017_47019.jpg

WS view: gasoline marker close-up.

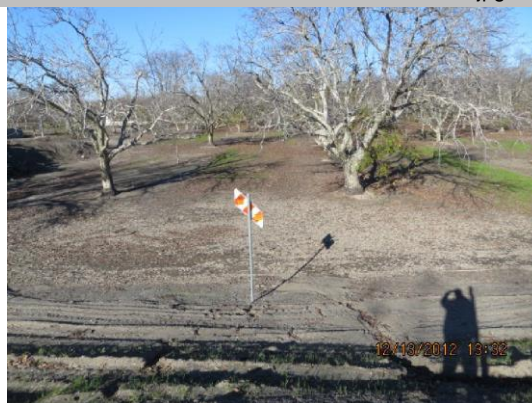
Photo 3 of 3 : UCIP_SP_2020_56017_47023.jpg

LS view: gas line marker on LS

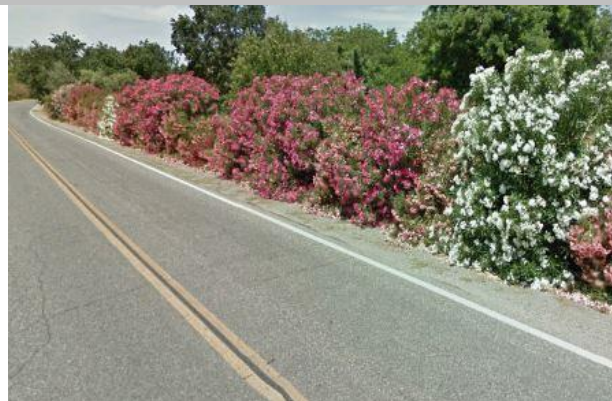
Photo 1 of 1 : SP_2020_ST0003_264_159_20200226_00024.jpg

View of the landscaping completely blocking visibility and access to the landside slope.

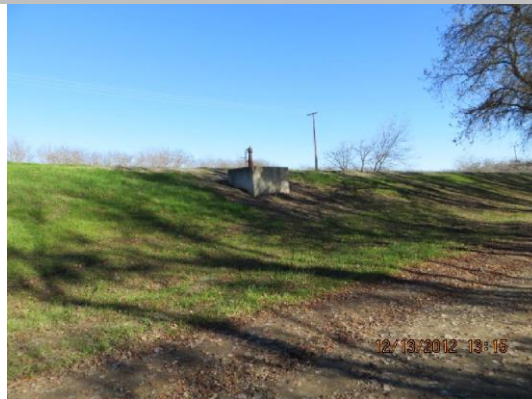
Photo 1 of 3 : UCIP_SP_2020_56018_47027.jpg

DS_ID:17309
FS_ID:56018
EP_NO: 9541
Repair Type: Non-Urgent
Crossing Status: Found
UCIP Comments: 07/29/2019 Record remains Non-Urgent, need to audit record to correct current owner of structure. Need to clarify owner for this crossing. Crossing was issued an ABO in 1974 however, this structure seems to be primarily used for drainage. Crossing is listed as LMA responsible and private owner. Crossing appears to be in good condition. (O. Magana - DWR UCIP)04/24/2017 Still no sign of WS pipe end or flap gate. LS appears to be in good condition. (DWR Sutter Yard- A Freitag) 11/07/2016 LS culvert measured to be 30"wide X 30"tall. WS end is not visible so could not be measured. (DWR Sutter Yard- A Freitag)06/06/2016 Cannot locate the WS headwall/flap gate. Appears to have been silted over.04/06/2015 Same as last inspection. Concrete surg box on WS. Flap gate in concrete "U" headwall at the waterward end- not found.06/30/2014 Same as last inspection.12/30/2013 Same as last inspection.07/29/2013 Same as last inspection.

WS view: overview- concrete surg tank

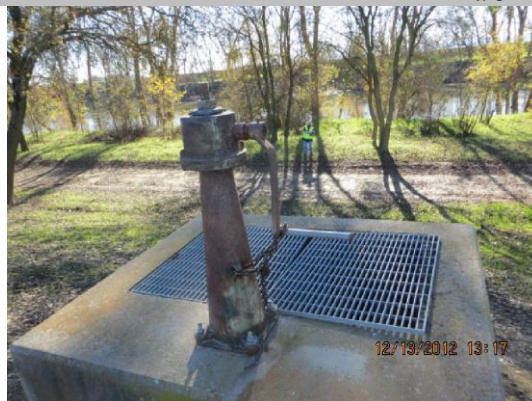
Photo 2 of 3 : UCIP_SP_2020_56018_47026.jpg

WS view: overview- concrete surg tank

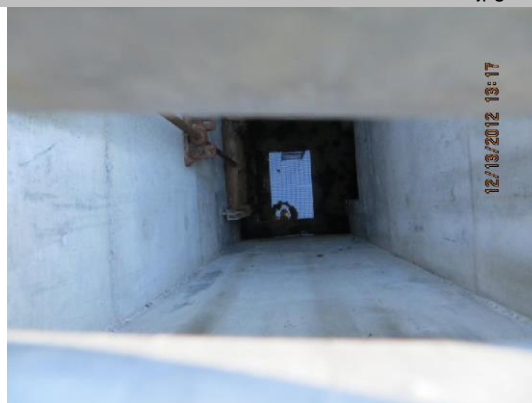
Photo 3 of 3 : UCIP_SP_2020_56018_47025.jpg

WS view: slide gate inside concrete surg tank

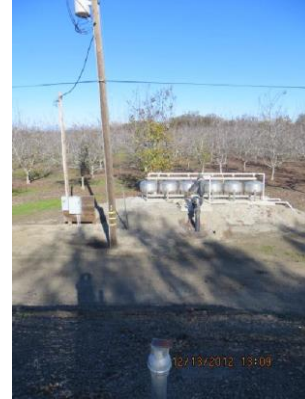
Photo 1 of 3 : UCIP_SP_2020_56019_47041.jpg

| DS_ID:17482 FS_ID:56019 EP_NO: 11590-A Repair Type: Non-Urgent Crossing Status: Found UCIP Comments: 07/29/2019 Record has been updated from No Action Needed to Non-Urgent, pipe has been modified. Pipe measured as a 12-inch pipe and not a 16-inch pipe as previously referenced in field description. Need to audit record to determine current owner and permit used to modify structure. (O. Magana - DWR UCIP)04/24/2017 Crossing appears to be in good condition. (DWR Sutter Yard- A Freitag)11/07/2016 Crossing appears to be in good condition. (DWR Sutter Yard- A Freitag)06/17/2016 Photos taken by Khalida on 4/5/2016 show the pump house when it was lifted off the platform for work to be done on the pump and pipe. My inspection on 6/6/2016 revealed a new blue pipe coupler installed on the open pipe beneath the pump house and the pump house was reinstalled on top of the pump platform. Crossing appears to be in good condition. (K. Fazel - DWR UCIP)04/04/2016 Same as last inspection.04/06/2015 No issues present.06/30/2014 Same as last inspection.12/30/2013 Same as last inspection.07/29/2013 Same as last inspection. FIELD_STRUCT_DESC: 16-inch steel irrigation pipe though the levee, 2 feet below the crown. Incline pump and corrugated metal sheet pump house on a steel structure on the waterside (WS). 12-inch intake pipe runs along the WS slope. Unable to confirm if 12-inch pipe also is sleeved through 16-inch pipe. An electrical pole on the WS shoulder. Siphon breaker off the landside (LS) shoulder. Sand filters found on the LS. (Permit No. 11590-A, 1976 - Ehrke). [Additional References: DWR Levee Log, 2002. USACE Sacramento O&M Manual 136, March 1960 (HLM 2.66)]. This pipe is a replacement for an existing 16-inch pipe (DSID 17310) abandoned and grouted in place under Permit No. 11590-A, 1976 - Ehrke. FS Date: 7/29/2019 11:14:00 AM | | | | | |

LS view: overview- siphon breaker and outlet pipe

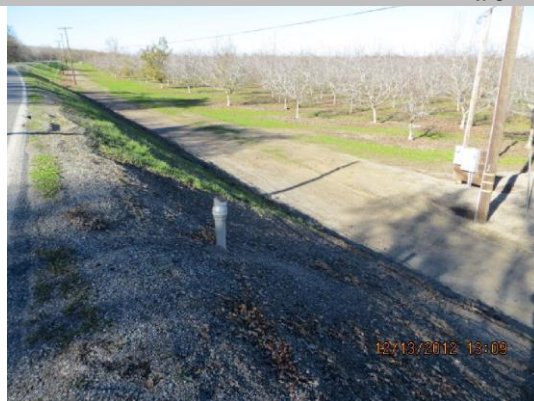
Photo 2 of 3 : UCIP_SP_2020_56019_47040.jpg

LS view: siphon breaker on levee slope

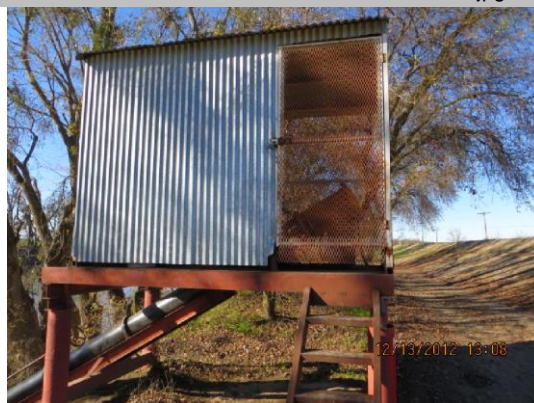
Photo 3 of 3 : UCIP_SP_2020_56019_47042.jpg

WS view: pump house

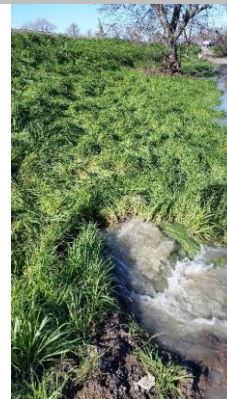
Photo 1 of 3 : UCIP_SP_2020_56020_76919.jpg

| <p>DS_ID:17311 FS_ID:56020 EP_NO: N/A Repair Type: Urgent Crossing Status: Found UCIP Comments: 07/30/2019 Record remains Urgent due to pipe integrity. DMP internal inspection was completed. Internal inspection noted surface damage corrosion and hole void visible, refer to DMP internal inspection report. New gate installed to control flood water entering pipe and flooding LS. No permit has been identified authorizing pipe. Pipe was not in use/clogged prior to the 2017 high water event. Owner will need to coordinate with CVFPB to properly remove or abandon pipe per Title 23 requirements. (O. Magana - DWR UCIP)08/30/2018 Pipe found; at a different Lat/Long than is listed, however. Revised Lat/Long is (39.196865, -121.985280; CLM 3.32). WS pipe end is visible and has a functioning slide gate; LS pipe end is exposed with no closure device or headwall. Keeping as Urgent because the LS pipe discharges into a hole and could pose a threat to the levee prism during a high water event. There are also cracks on the crown that could be related to the pipe beneath. Recommend an internal pipe inspection to be sure of the levee integrity (D.Sanoski - DWR UCIP).04/06/2017 Pipe was found in January 2017 during a high water event when water uncovered the buried WS end which led to uncontrolled water flow through during the high water event. The WS pipe opening was temporarily blocked off by plywood and sandbags until the pipe can be properly plugged or abandoned. Pics updated. (DWR Sutter Yard- Afreitag)11/07/2016 Unable to locate. (DWR Sutter Yard- AFreitag)06/06/2016 Unable to locate.04/06/2015 Unable to locate.06/30/2014 Unable to locate.12/30/2013 Unable to locate.07/29/2013 Same as last inspection. Unable to locate. FIELD_STRUCT_DESC: 24-inch corrugated metal drainage pipe through the levee, 12.4 feet below the crown. Slide gate on the waterside (WS) end. (Automatic Board Order (ABO) issued as Permit No. 9539, 1974 - Locvich). [Additional Reference(s): DWR Levee Log, 2002. USACE Sacramento O&M Manual 136, March 1960 (HLM 3.25)]. FS Date: 7/30/2019 10:49:00 AM</p> | | | | | |

LS view of water exiting the pipe.

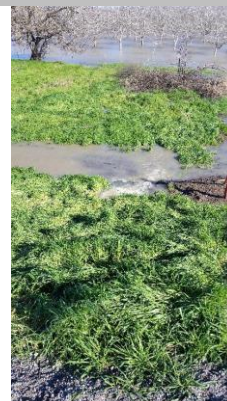
Photo 2 of 3 : UCIP_SP_2020_56020_76920.jpg

LS view from levee shoulder

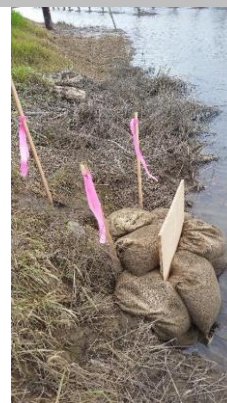
Photo 3 of 3 : UCIP_SP_2020_56020_76921.jpg

WS view of the temporary plug on WS end.

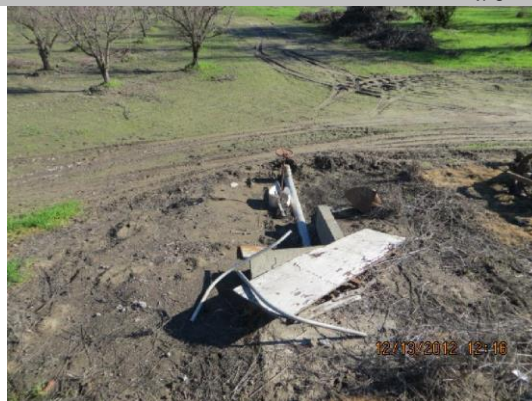
Photo 2 of 3 : UCIP_SP_2020_56021_47046.jpg

DS_ID:17312
FS_ID:56021
EP_NO: 9539
Repair Type: Urgent
Crossing Status: Found
UCIP Comments: 07/30/2019 Record remains Urgent, pipe is considered a flood risk. Crossing has been modified from its original design. The separation between the old concrete wall and the new concrete wall causes for flood water to enter the crossing and flood the LS. Flooding was observed during high water patrols in February 2019 and Jan/Feb 2017. No permit has been identified authorizing modifications. (O. Magana - DWR UCIP)08/30/2018 Same as last inspection. Recommend internal pipe inspection to verify pipe integrity and levee integrity so crossing remains Urgent (D. Sanoski - DWR UCIP).04/24/2017 Pipe leaked during the Jan/Feb 2017 high water event. Gap between the top of the WS headwall and concrete plug plus the WS air vents going underwater are the cause of the uncontrolled water flows. (DWR Sutter Yard- AFreitag)11/07/2016 Nothing has changed with this crossing since the last inspection. The gap between the top of the WS headwall and concrete plug could be a problem with water flow during high water times. (DWR Sutter Yard- AFreitag)06/06/2016 One of the pipes appear to be leaking inside of the concrete culvert. From the WS headwall water can be heard flowing inside of the levee behind the concrete plug. The concrete plug also appears to leak as water current can be seen flowing around it. There is also a 1" gap at the top of the plug and the old WS headwall that will allow high water to flow through uncontrolled. (DWR Sutter Yard - afreitag)04/06/2015 6-inch and 18-inch pipes still present in crossing and WS end still plugged with concrete. It seems that the system was originally designed for drainage but later converted into an irrigation system. 6-inch GI pipe and 18-inch PVC pipes inserted into culvert from LS (not plugged). WS opening is plugged with concrete. Probably pump is located 350 ft from levee as seen from Google Earth Map. (DWR Sutter Yard - afreitag)06/30/2014 Same as last inspection. (DWR Sutter Yard - afreitag)12/30/2013 Same as last inspection. (DWR Sutter Yard - afreitag)07/29/2013 Same as last inspection. (DWR Sutter Yard - afreitag)

LS view: overview- concrete culvert and pipes

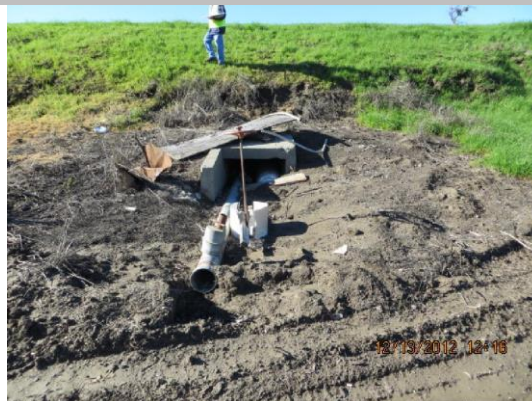
Photo 3 of 3 : UCIP_SP_2020_56021_47047.jpg

LS view: overview of concrete culvert and pipes

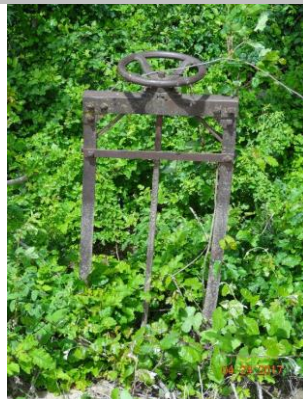
Photo 1 of 3 : UCIP_SP_2020_56022_77004.jpg

DS_ID:17313
FS_ID:56022
EP_NO: N/A
Repair Type: Non-Urgent
Crossing Status: Found
UCIP Comments: 07/30/2019 Record remains Non-Urgent, pipe has been abandoned. Coordinates have been updated from 39.201831, -121.984006 to 39.2016497, -121.9840750 based on the DMP Geophysics Study and UCIP field confirmation. Per the DMP Geophysics Study the pipe is still present through the levee. LMA will need to monitor levee section until funds become available to remove or properly abandon pipe through the levee. (O. Magana - DWR UCIP)04/24/2017 Slide gate structure found on WS about 10ft from levee toe. Vegetation was too thick to see if there were any more appurtenances associated with this crossing visible on the WS. Nothing was visible on the LS. House located above pipe alignment at LS levee toe. Crossing appears abandoned and should be done so properly. (DWR Sutter Yard- A Freitag)11/07/2016 Unable to locate. (DWR Sutter Yard- A Freitag)06/06/2016 Unable to locate.04/06/2015 Unable to locate.06/30/2014 Unable to locate.12/30/2013 Unable to locate07/29/2013 Same as last inspection. Unable to locate. FIELD_STRUCT_DESC: *ABANDONED* 18-inch corrugated metal drainage pipe through the levee, 15 feet below the crown. Slide gate on the waterside (WS) end. [Additional Reference(s): DWR Levee Log, 2002. USACE Sacramento O&M Manual 136, March 1960 (HLM 3.6)]. FS Date: 7/30/2019 10:52:00 AM

Slide gate structure found on WS

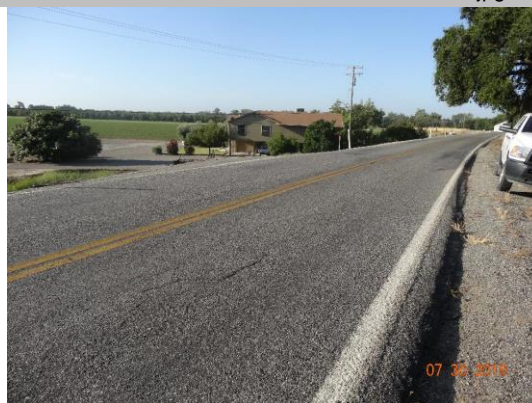
Photo 2 of 3 : UCIP_SP_2020_56022_80177.jpg

Overview of levee crown looking d/s towards crossing.

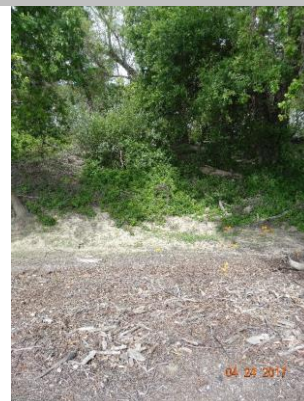
Photo 3 of 3 : UCIP_SP_2020_56022_77005.jpg

View of WS from levee shoulder

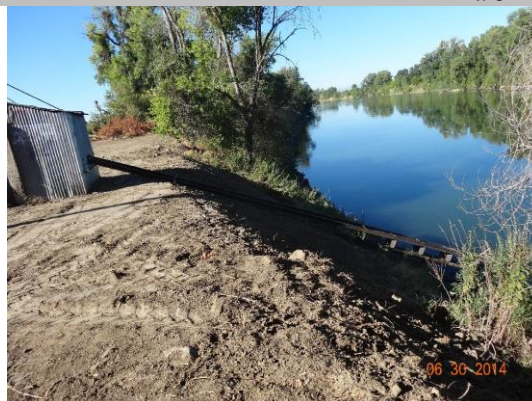
Photo 1 of 3 : UCIP_SP_2020_56025_71480.jpg

DS_ID:17314
FS_ID:56025
EP_NO: 9501-1
Repair Type: Urgent
Crossing Status: Found
UCIP Comments: 07/30/2019 Record has been updated from Non-Urgent to Urgent due to levee integrity. Erosion present on LS slope caused by leaky siphon breaker. LMA supervisor, B. Reniff, has been notified. Supervisor will notify owner to address issue. Need updated photo of repair. (O. Magana - DWR UCIP)04/24/2017 Crossing appears to be in good condition. (DWR Sutter Yard- A Freitag)11/07/2016 Crossing appears to be in good condition. (DWR Sutter Yard- A Freitag)06/17/2016 DO NOT BELIEVE THIS IS AN ABANDONED CROSSING- there is a newer looking pump present inside the WS pump house with an active PG&E power meter. Also the dirt below the siphon breaker inside of the riser on the LS shoulder was wet indicating that the breaker has had running water through it recently. Also the ground under the LS toe air vent was wet indicating that it too has recently had water flowing through it. 04/04/2016 Concrete box on LS still silted in. Cracking and slope failure previously cited appears to have been repaired as we could not locate. Shutoff valves appear in good condition. If crossing is abandoned, should be done so properly. 04/06/2015 Same as last inspection. Concrete pit on WS berm. Concrete distribution box on LS silted and erosion around the box. Slope failure/ transverse cracks on LS levee slope. Two depressions on WS berm. 06/30/2014 Crossing appears to be being made active again. WS bank has been cleared of all vegetation and debris to allow pump to slide down to water level. New shutoff valve installed on WS shoulder inside of cmp stand pipe. New air-vac installed inside cmp standpipe on LS shoulder and air vent installed on LS toe. Could not locate pipe end on LS. Need to check for permit number for work done. 12/30/2013 Repairs to LS and WS slopes have been completed. Not sure if this is an active or abandoned crossing. LS distribution box is still silted in. 07/29/2013 Repairs to LS slope and pipe are in progress. Nothing has been done yet to the WS depressions.

WS river bank

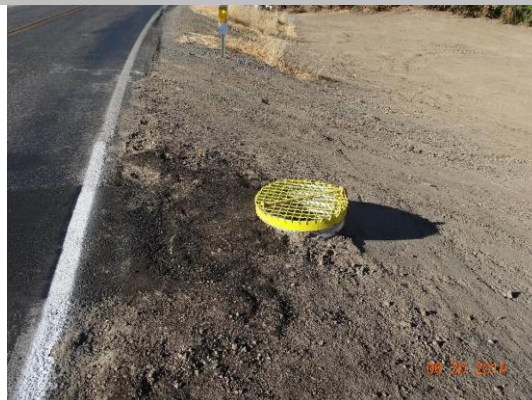
Photo 2 of 3 : UCIP_SP_2020_56025_71479.jpg

WS standpipe with shut off valve inside

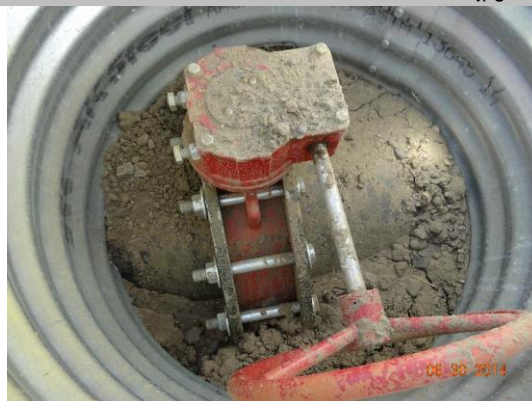
Photo 3 of 3 : UCIP_SP_2020_56025_71478.jpg

WS shut off valve

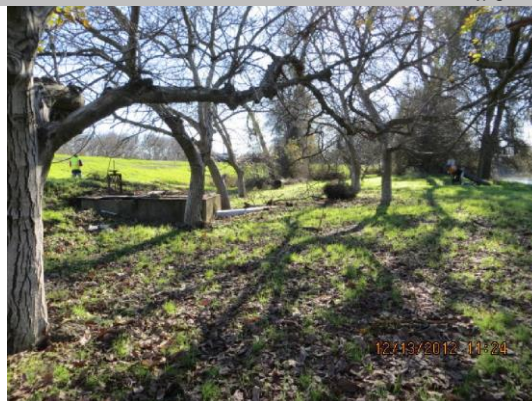
Photo 1 of 3 : UCIP_SP_2020_56026_47063.jpg

DS_ID:17325
FS_ID:56026
EP_NO: 1368
Repair Type: Non-Urgent
Crossing Status: Found
UCIP Comments: 07/30/2019 Record has been updated from No Action Needed to Non-Urgent, as a safety measure need to contact owner to determine current condition of pipe through the levee. Pipe was originally installed in 1949 and last modified in 1969. Levee section is also considered Butte Slough Road. For safety reasons, recommend internal inspection be conducted of pipe through the levee to determine integrity of pipe through levee/Butte Slough Road. Also need to audit record to determine current owner. (O. Magana - DWR UCIP)04/24/2017 Crossing appears to be in good condition. (DWR Sutter Yard- A Freitag)11/07/2016 Crossing appears to be in good condition. (DWR Sutter Yard- A Freitag)06/06/2016 Pump was running and flowing water through crossing. Appears to be in good condition.04/06/2015 Same as last inspection. A concrete standpipe/distribution box on LS.06/30/2014 Same as last inspection.12/30/2013 Same as last inspection.07/29/2013 Same as last inspection.

WS view: overview

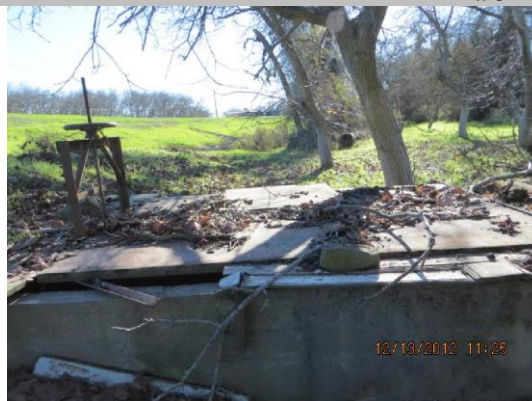
Photo 2 of 3 : UCIP_SP_2020_56026_47061.jpg

WS view: concrete surge box

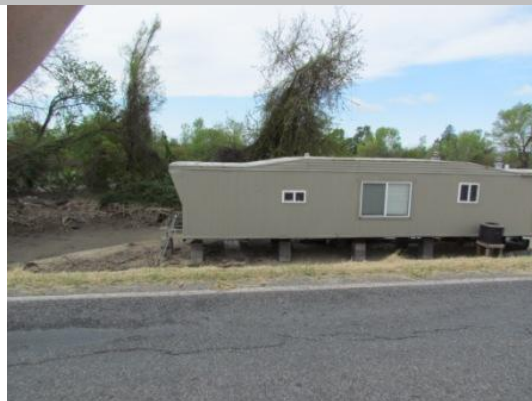
Photo 1 of 1 : SP_2020_ST0003_264_11_20200226_00006.jpg

View of a trailer next to the waterside toe.

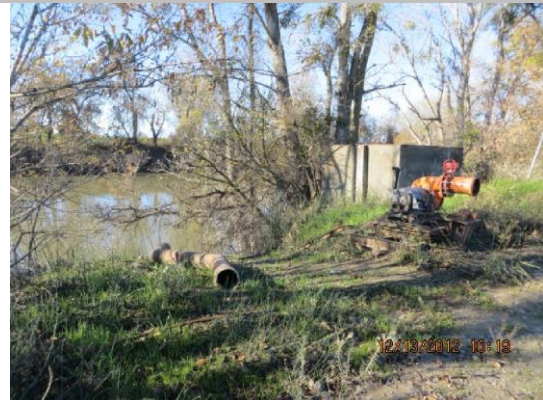
Photo 2 of 3 : UCIP_SP_2020_56042_47067.jpg

DS_ID:17297
FS_ID:56042
EP_NO: 9501-A
Repair Type: Non-Urgent
Crossing Status: Found
UCIP Comments: 07/30/2019 Record remains Non-Urgent, minor surface erosion present on the WS slope. Pipe system found on the WS appears to be abandoned. Need to audit record to determine current owner of pipe system. If pipe system is no longer in use owner will need to coordinate with the CVFPB to properly remove or abandon per Title 23 requirements. (O. Magana - DWR UCIP)08/30/2018 Same as last inspection, with no signs of any improvements made to pipe or pump. Vegetation obstructed full inspection at water level, but the levee looks in very good condition with no signs of threat. Downgrading to Non-Urgent from Urgent due to the good condition of the levee (D. Sanoski - DWR UCIP).04/24/2017 WS was mostly underwater during site visit. Not sure if the 10" pipe was still opened or capped on the WS end but no water appeared to be free flowing through the levee. No sign of orange pump. (DWR Sutter Yard- AFreitag)11/07/2016 Orange pump was not present at this inspection. 10" pipe penetration left opened on WS end. (DWR Sutter Yard- AFreitag)06/17/2016 Orange pump motor was lowered down the WS berm to water level and was pumping water through the pipe to the LS outlet. What is pictured in (photo#17 UCIP_Photos_No.75150) as "pipe debris" is the pipe section that is used to connect the orange pump to the open 10" pipe that penetrates the levee. In the same photo the "possible penetration" is the flexible suction line for the pump. (DWR Sutter Yard - afreitag)04/04/2016 Flow meter installed on LS indicates this pipe is used seasonally and not abandoned. Pipe open on WS (see photo). No cover on old siphon breaker. Slight sloughing of LS slope. (DWR UCIP - kfazel)04/06/2015 Pump disconnected and pulled up to WS toe. Not Sure if leaky valve has ever been fixed. (DWR Sutter Yard - afreitag)06/30/2014 Same as last inspection. (DWR Sutter Yard - afreitag)12/30/2013 Same as last inspection. (DWR Sutter Yard - afreitag)07/29/2013 Not an abandoned crossing. Pump is connected to WS pipe end at water level and is pumping water to LS and then goes underground to an irrigation ditch about 100yds. upstream. Pump and pipes are disconnected and pulled up to WS toe for high water season. Leaky valve on LS shoulder does not appear to have been fixed. (DWR Sutter Yard - afreitag)12/12/2012 Motor and pump on berm. Appears an abandoned crossing. Leaky valve on LS slope. Pipe removed and laying on berm. No electric connection to the pump. (DWR UCIP - pamatya)

WS view: overview of pump and abandoned pipe

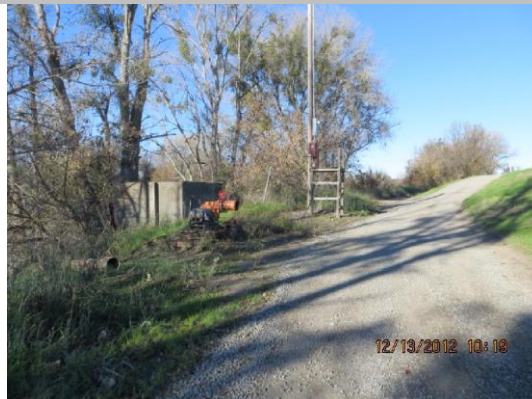
Photo 2 of 3 : UCIP_SP_2020_56043_47079.jpg

WS view: overview
